CLEARVIEW LAKE DAM

NJ 00147

PHASE 1 INSPECTION REPORT NATIONAL DAM SAFETY PROGRAM

79 09 24 034
August, 1979

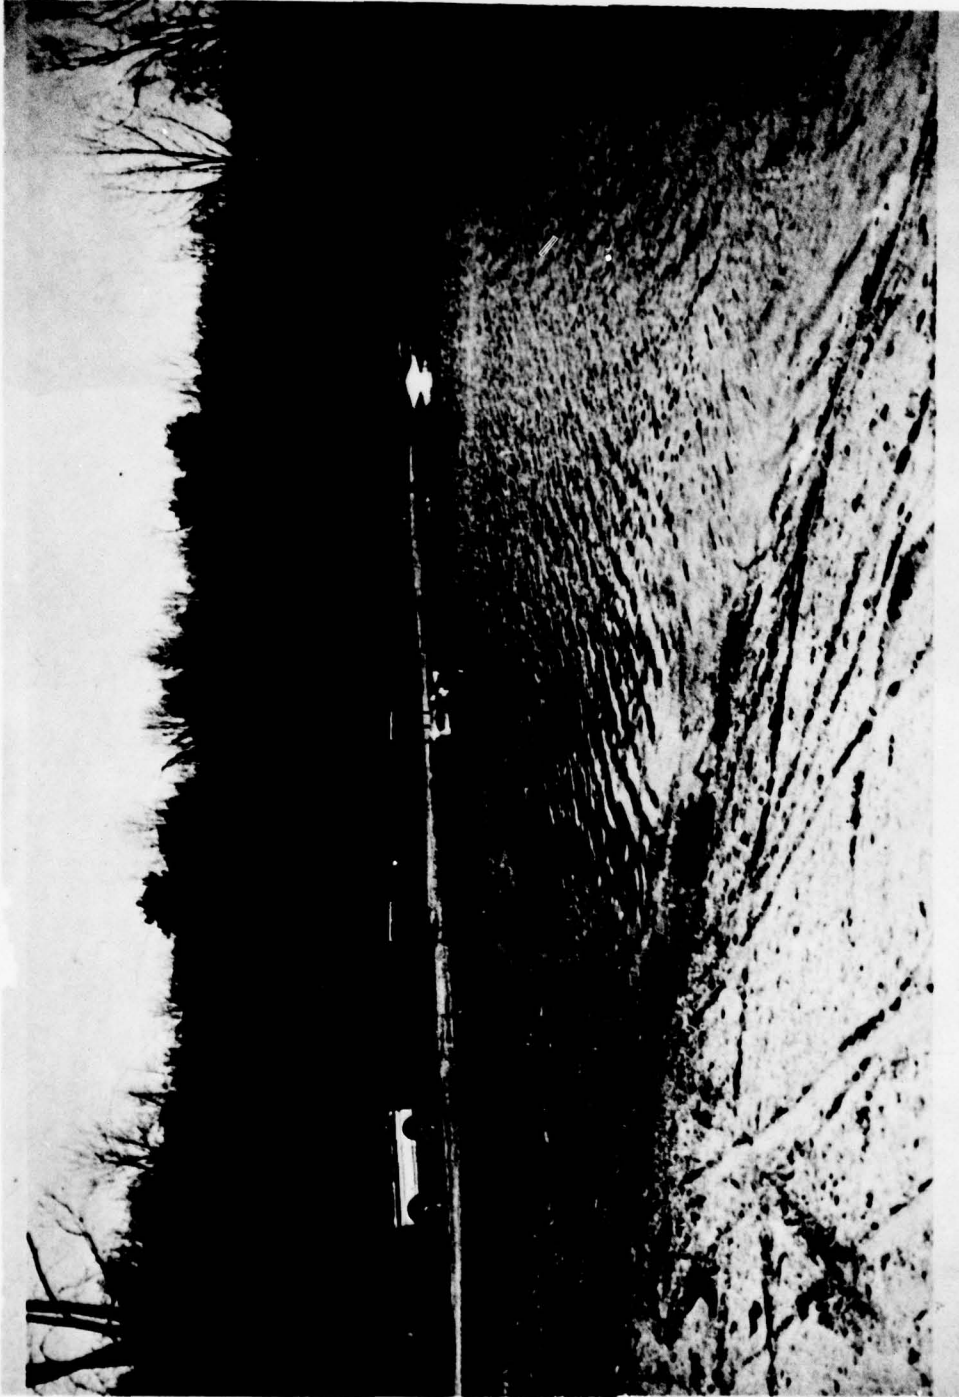
OVERVIEW OF CLEARVIEW LAKE DAM

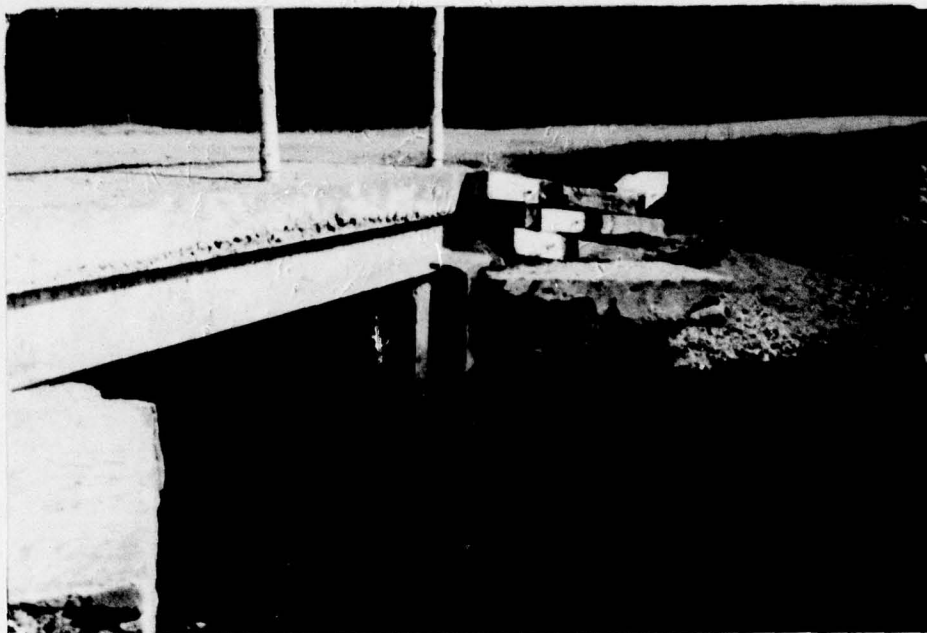
VISUAL EXAMINATION OF	OBSERVATIONS	REMARKS OR RECOMMENDATIONS
CONCRETE SILL	Cracked. Concrete inlet apron broken and spalled.	Requires reconstruction.
APPROACH CHANNEL	Wingwalls undercut and pulling away from side walls. Footing completely spalled and deteriorated on bottom.	Requires reconstruction
DISCHARGE CHANNEL	Collapsed apron is broken away from crest slab; footings and side walls undercut, broken, spalled and generally deteriorated.	Requires reconstruction
BRIDGE AND PIERS	Sidewalls are concrete. Bridge is 9" thick concrete slab supported on steel "I" beams.	
Gates and Operation Equipment	Stop logs missing. Concrete slot spalled and broken.	Stop logs were in place the month prior to the inspection as indicated by preliminary reconnaissance photographs.

View of Spillway Inlet

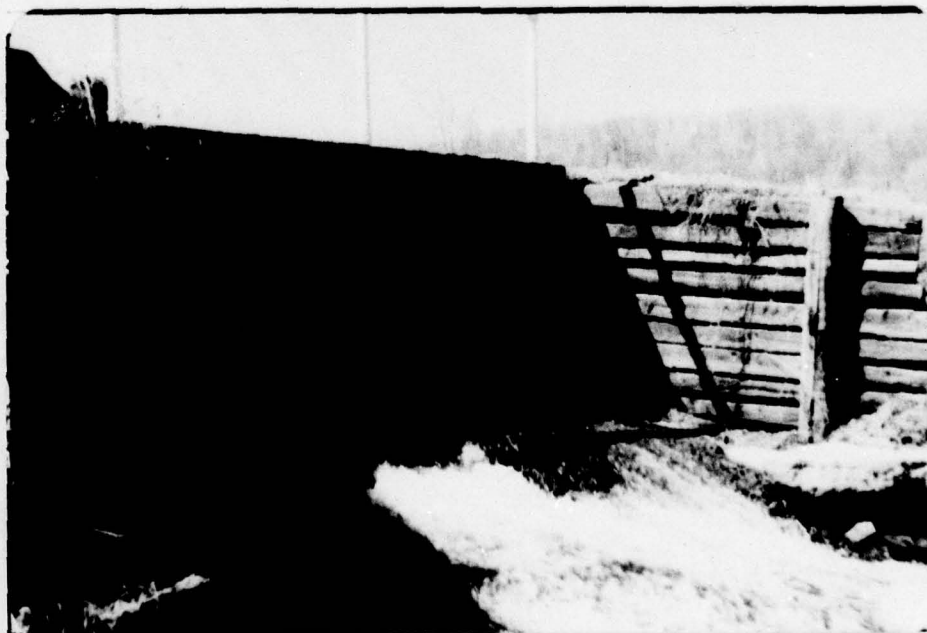
The primary spillway is located about 150 feet from the right abutment and consists of a 3 feet high x 7.5 feet wide steel I-beam and concrete bridge with a paved invert. Discharge through the outlet flows down a short concrete apron to the rock-strewn downstream channel. The upstream wingwalls are masonry while railroad ties form the downstream retaining wingwalls. The upstream wingwalls are in an advanced state of deterioration and are completely undercut. Stoplog slots, located at the junction of the wingwalls and the culvert sidewalls are demolished. The sidewalls are severely spalled and cracked and at the downstream ends, have separated from the sill. The outlet apron has broken away from the sill and is partially collapsed. Although the timber cribbing of the downstream retaining wingwalls appears in fair condition, the concrete footings under the cribbing are undermined and the walls tilted toward the channel. The 9 inch thick concrete deck slab is spalled along its edges and fascia and the steel I-beams are rusted.

In general, the spillway structure is in an advanced stage of deterioration and its long-term stability is questionable. At the time of inspection, there were no stop logs in place and the culvert discharge was about 20 cfs.

View of Spillway Outlet
